AFML-TR-76-173

## EXPLORATORY DEVELOPMENT ON DURABILITY OF ADHESIVE BONDED JOINTS

BOEING COMMERCIAL AIRPLANE COMPANY  
P.O. BOX 3707  
SEATTLE, WASHINGTON 98124

TECHNICAL REPORT AFML-TR-76-173  
FINAL REPORT FOR PERIOD FEBRUARY 1974 - OCTOBER 1976

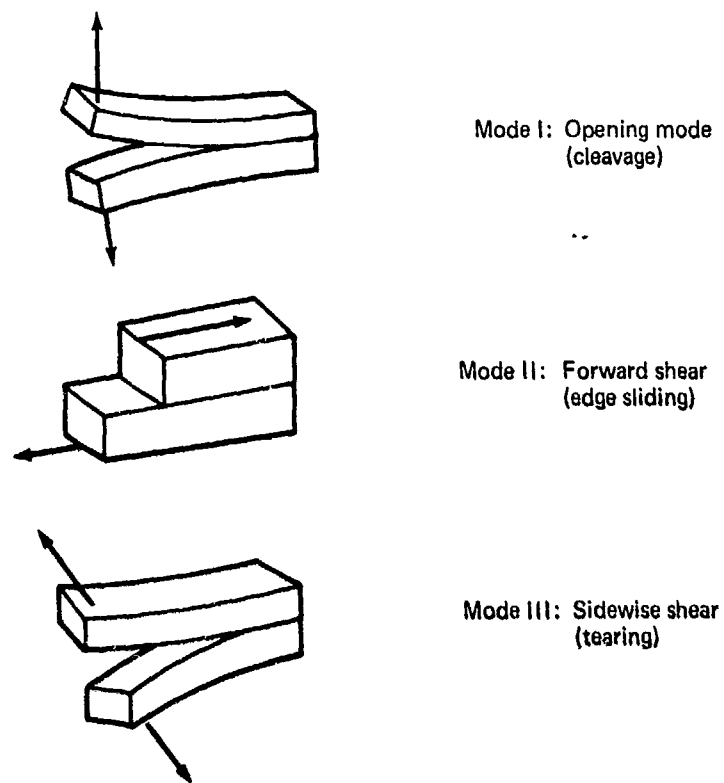
Figure 1.—Loading Modes Possible in Bonded Materials

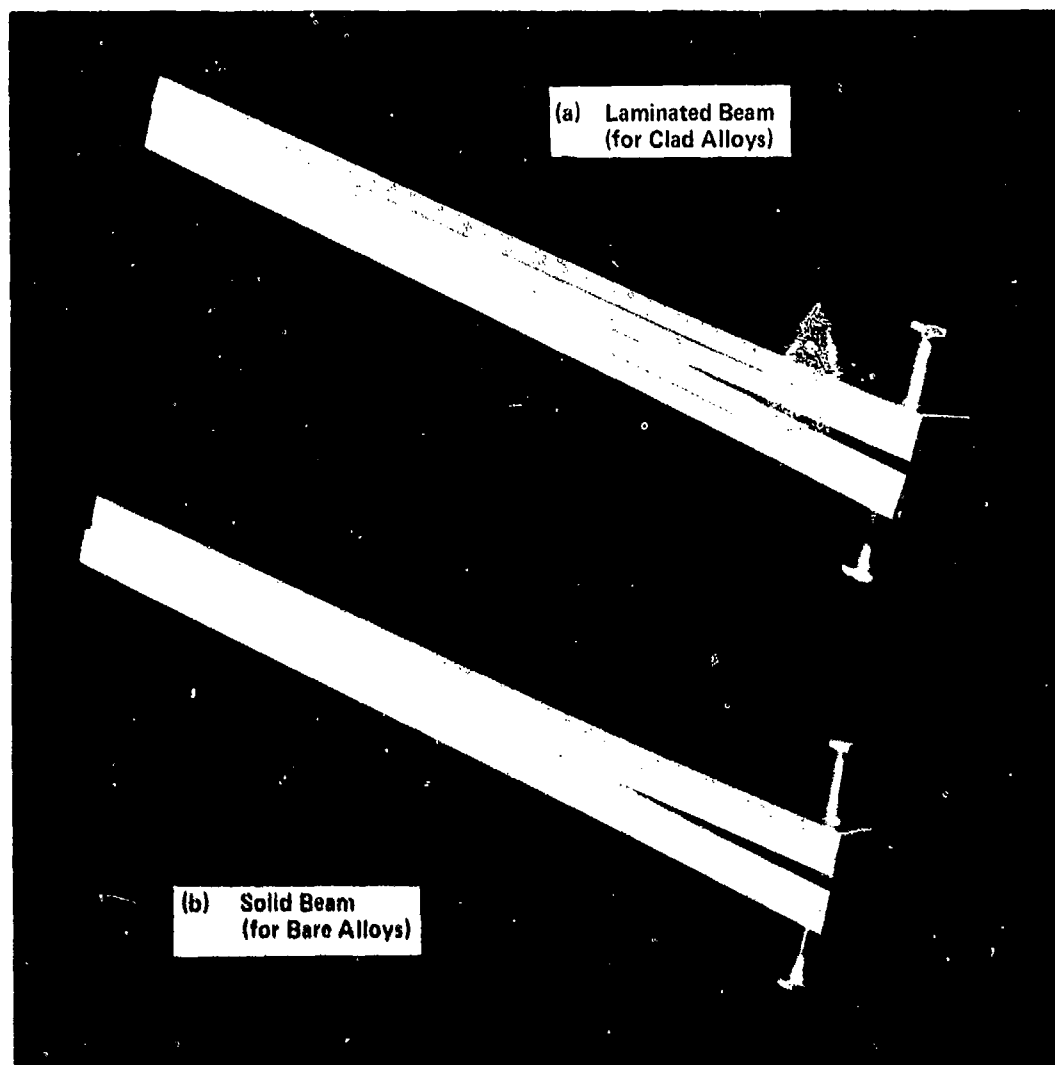
*Figure 3.—Thick-Adherend DCB Specimens*

Thick-adherend DCB specimens for each of the four alloys, four adhesives, three surface treatment processes, and three corrosion-inhibiting primers were fabricated by cutting specimens from large bonded assemblies and milling the cut sides to produce smooth surfaces (fig. 3). DCB specimens for each of the clad alloys were fabricated by bonding four 1/4-in.-thick plates to make up the 1-in.-thick specimen. This was necessary since 1/2-in.-thick clad plate could not be purchased at an acceptable cost. The specimens were stressed by tightening two 1/4-28 bolts into one end until a displacement of 0.10 in. was obtained (fig. 3). This displacement was chosen for convenience to standardize specimen configuration. After waiting 1 day for equilibrium to be established, the tip of the crack front created in the bondline was marked.

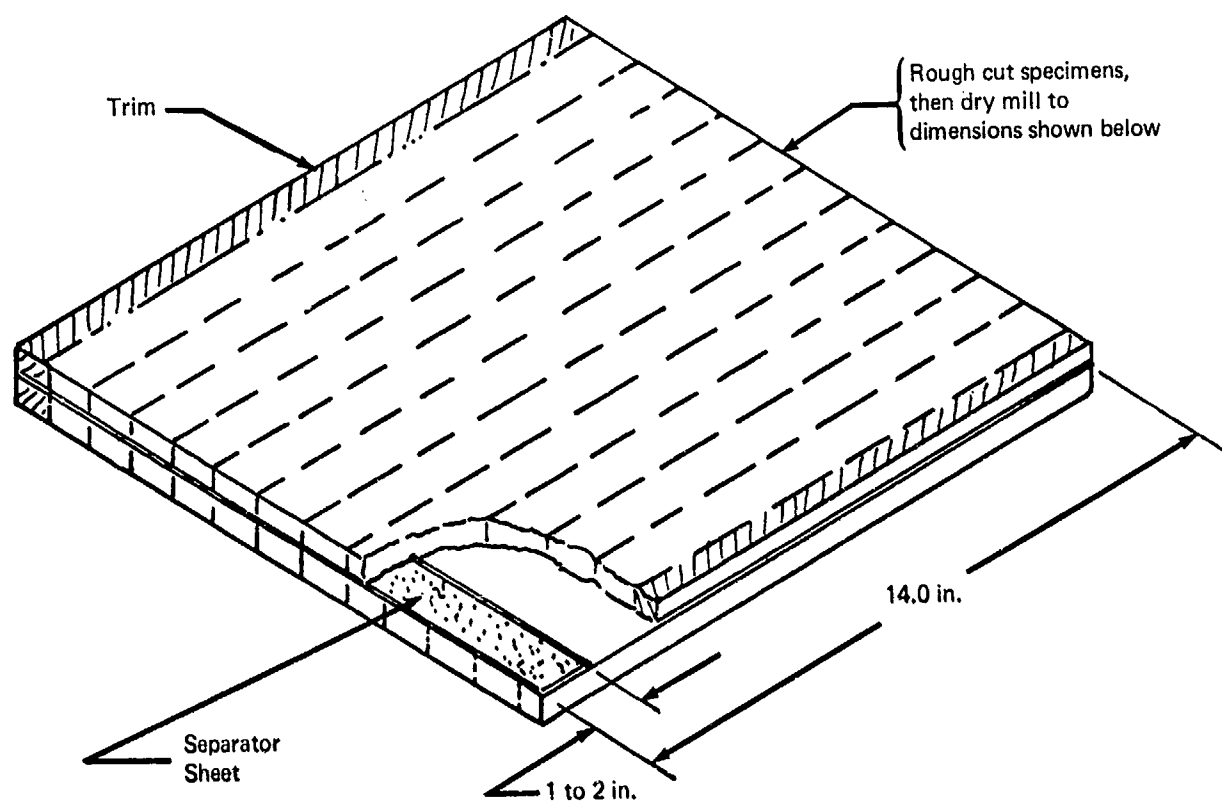
(c) Typical DCB Specimen Bonded Assembly

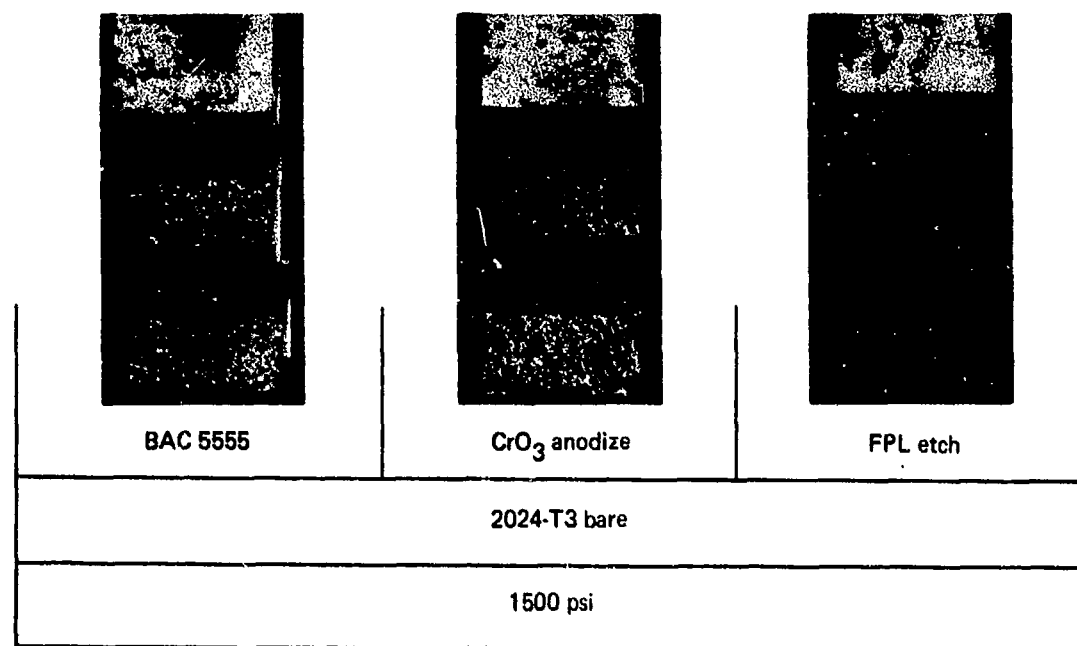
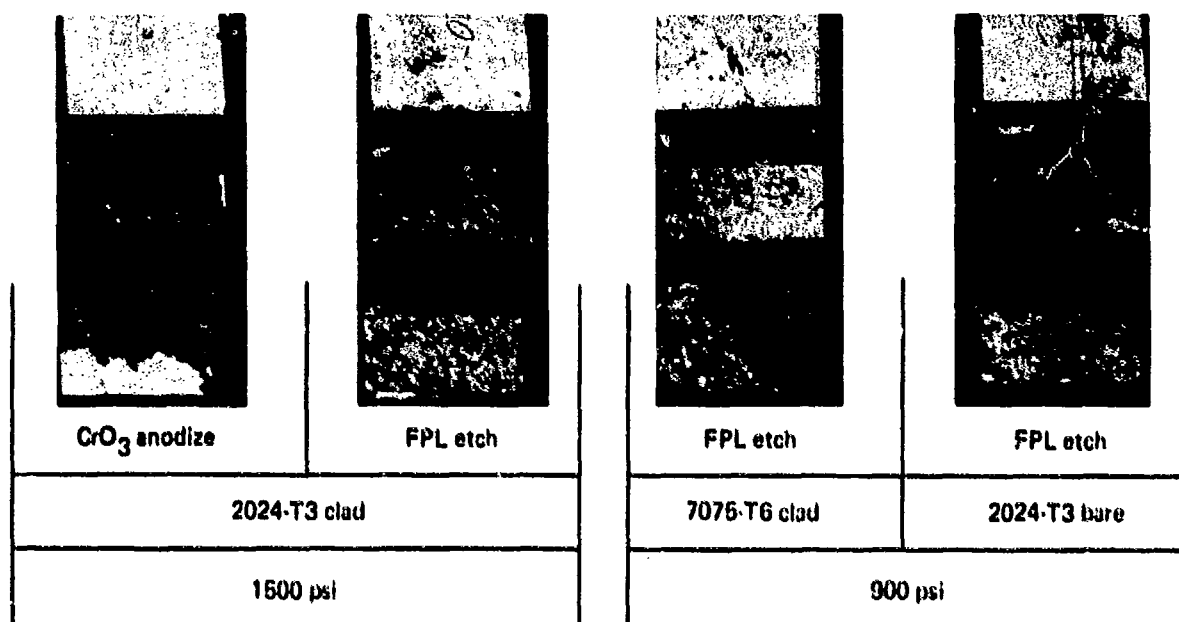
Adhesive System: FM 123-2/BR 127

Figure 8.—Typical Thick-Adherend Lap-Shear Specimen Failures for Sustained-Stress Tests Exposed to 140° F/Condensing Humidity

This test method discriminates between adhesive systems; i.e., most of the failures occurred with the FM 123-2/BR 127 adhesive/primer system, some failures occurred with the new technology adhesive/primer system EA 9628/BR 127, but no failures occurred with either of the two 350° F cure adhesive/primer systems. Surface treatments and alloys did not have a significant effect on the time to failure or the failure modes. Typical failure modes are shown in figure 8.

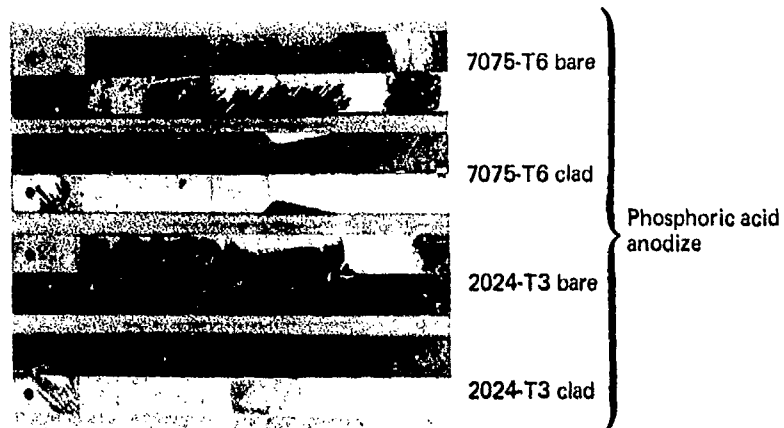
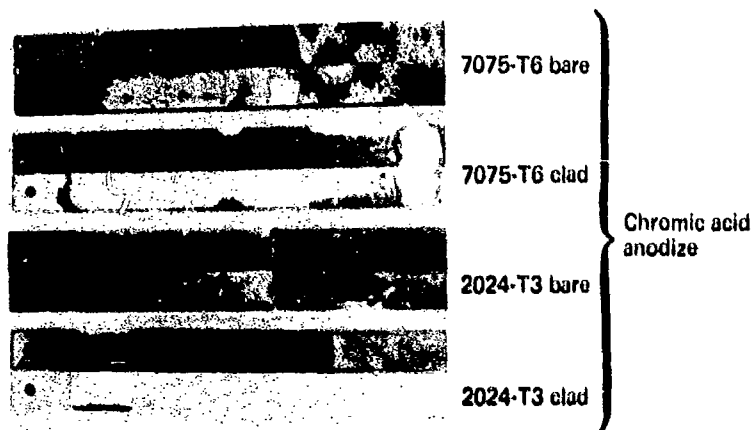
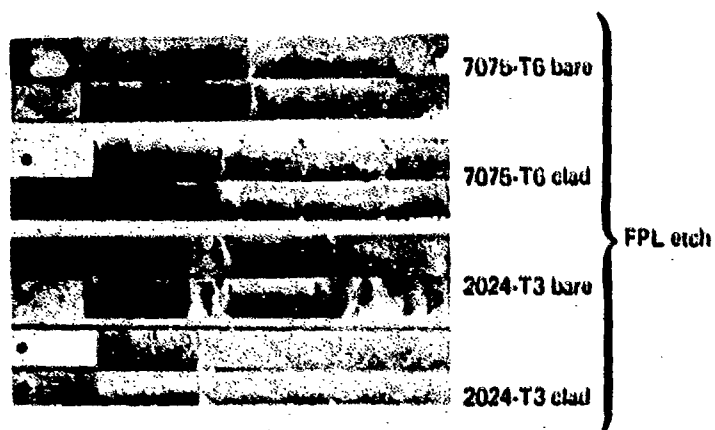
→ Crack growth

(a) With 20 Weeks' Exposure to 140°F/Condensing Humidity

Figure 10.—Opened DCB Specimens Bonded with PL 729-3/PL 728

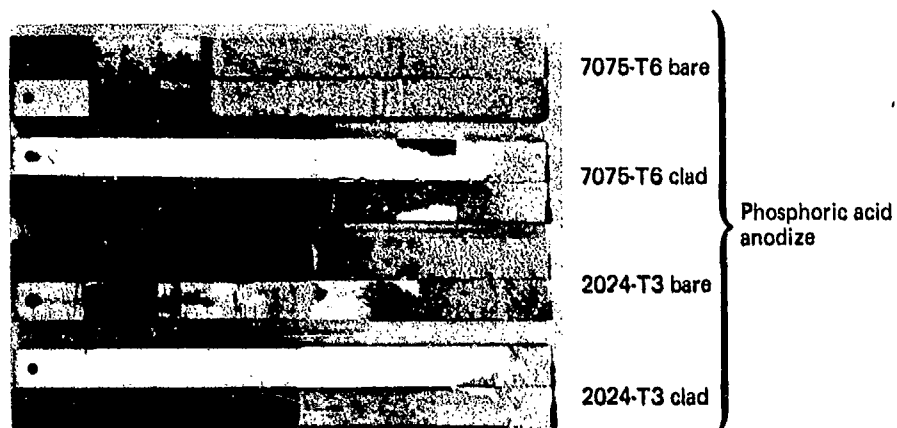
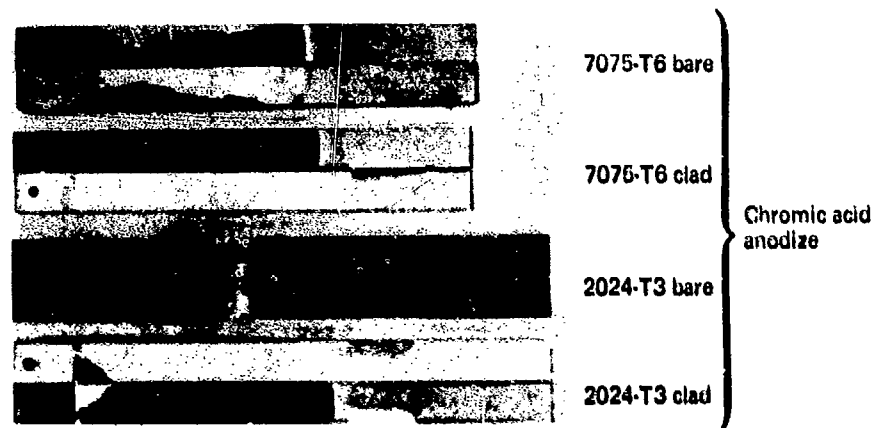
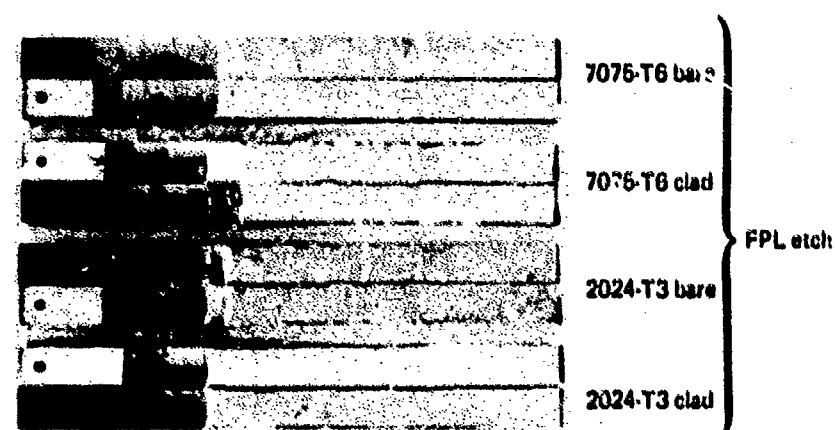
(b) With 77 Weeks' Exposure to 140°F/Condensing Humidity

Figure 10.—(Concluded)

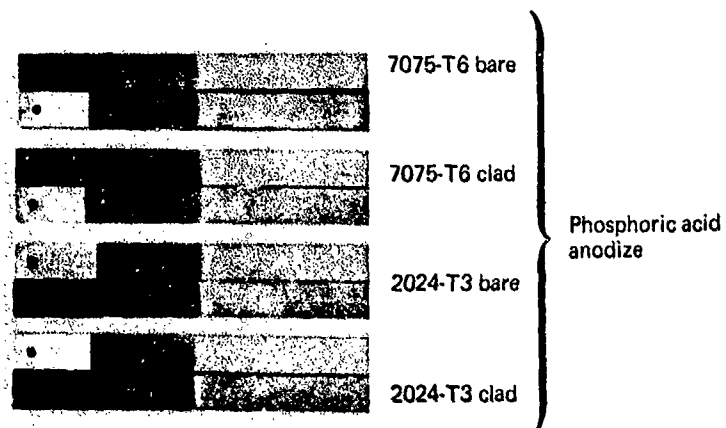
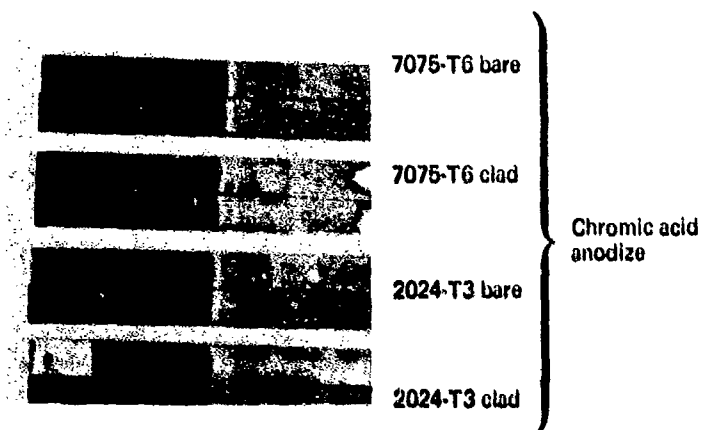
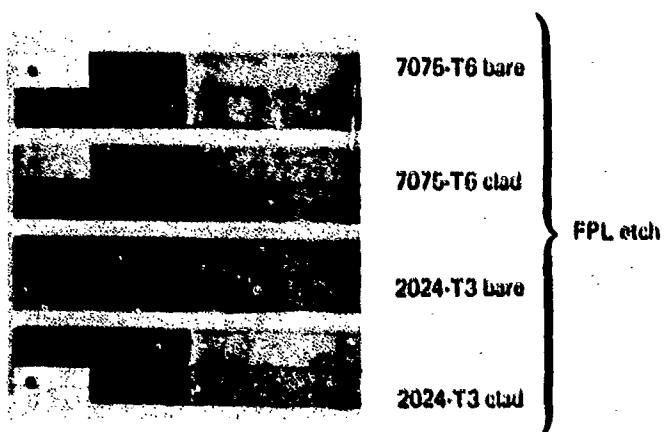
(a) With 20 Weeks' Exposure to 140°F/Condensing Humidity

**Figure 11.—Opened DCB Specimens Bonded With AF 143/EC 3917 System**

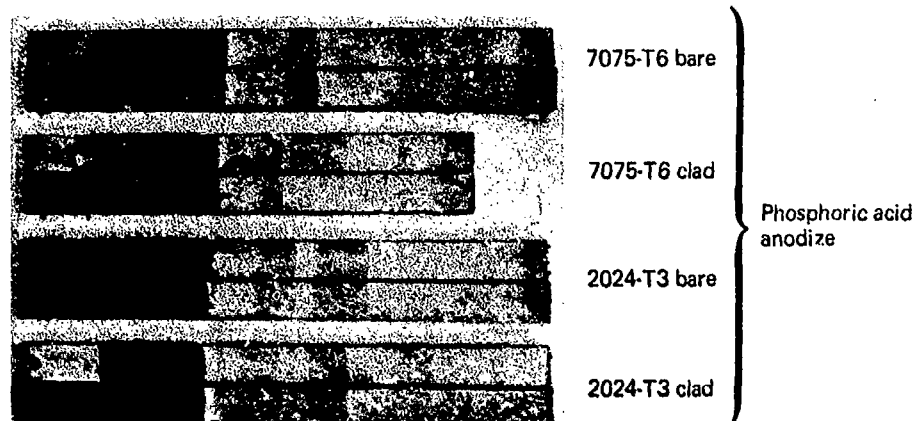
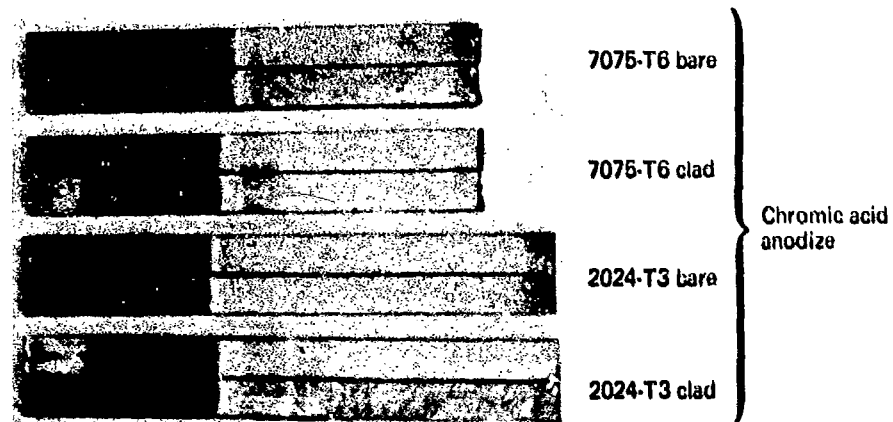
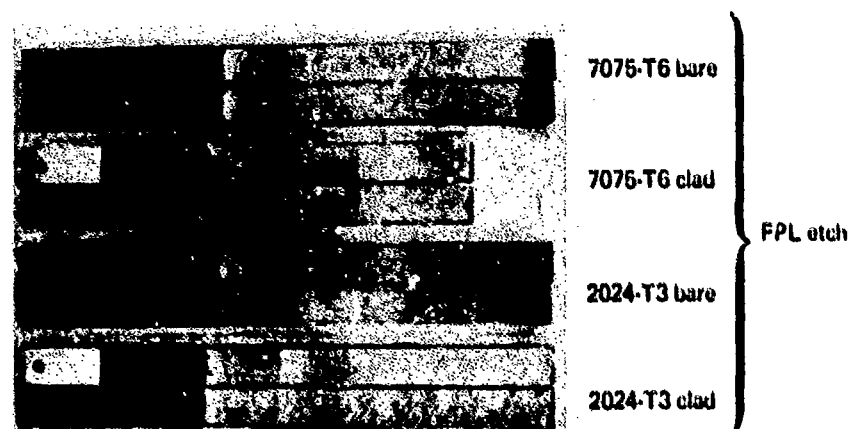
(b) With 77 Weeks' exposure to 140°F/Condensing Humidity

Figure 11.—(Concluded)

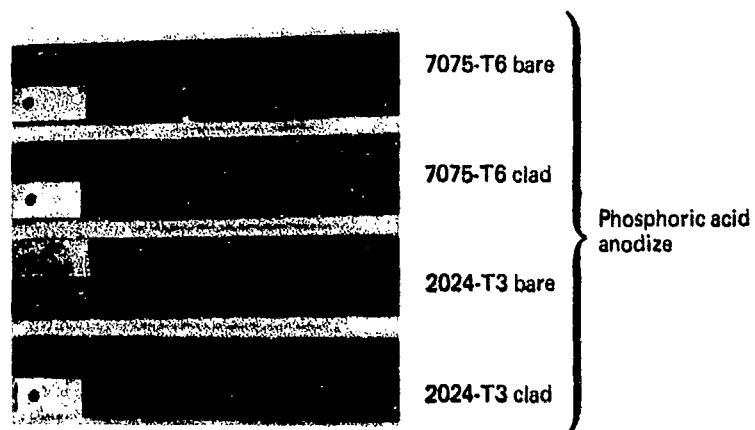
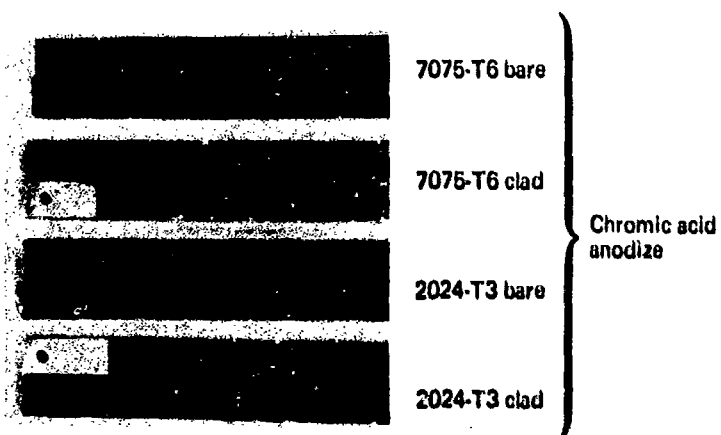
(a) With 20 Weeks' Exposure to 140°F/Condensing Humidity

**Figure 12.—Opened DCB Specimens Bonded With FM 123-2/BR 127 System**

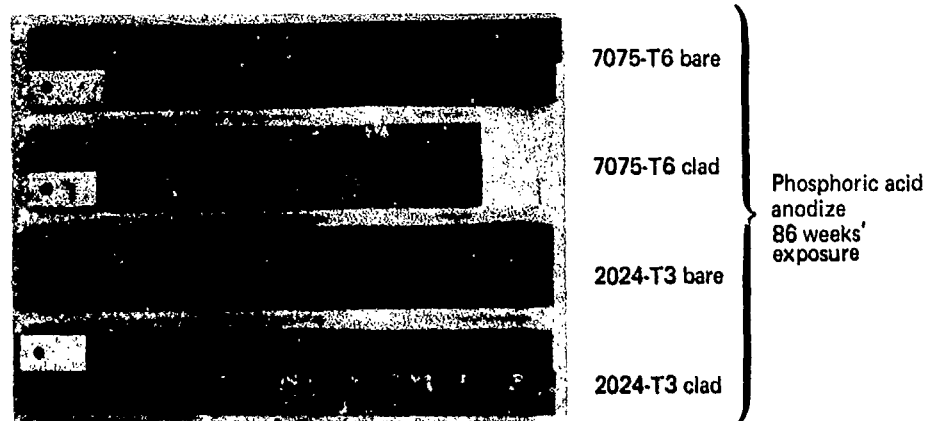
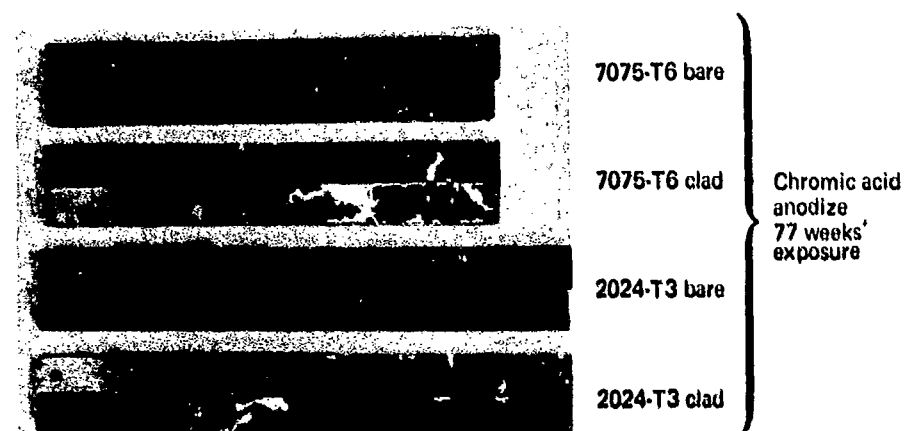
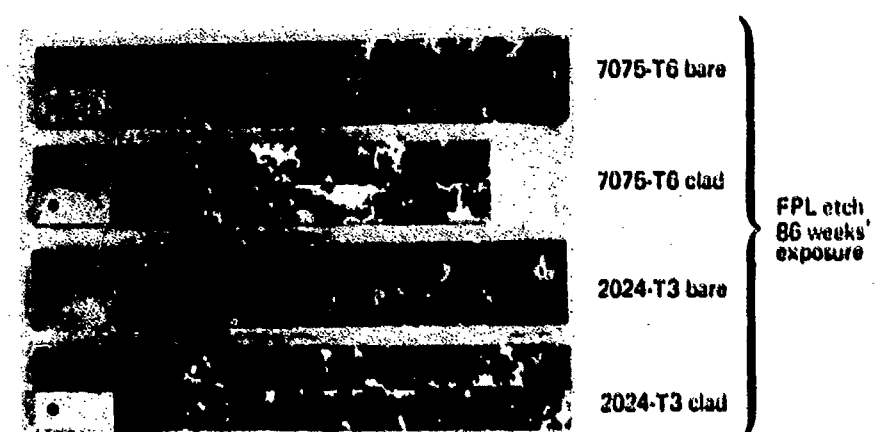
(b) With up to 86 Weeks' Exposure to 140°F/Condensing Humidity

Figure 12.—(Concluded)

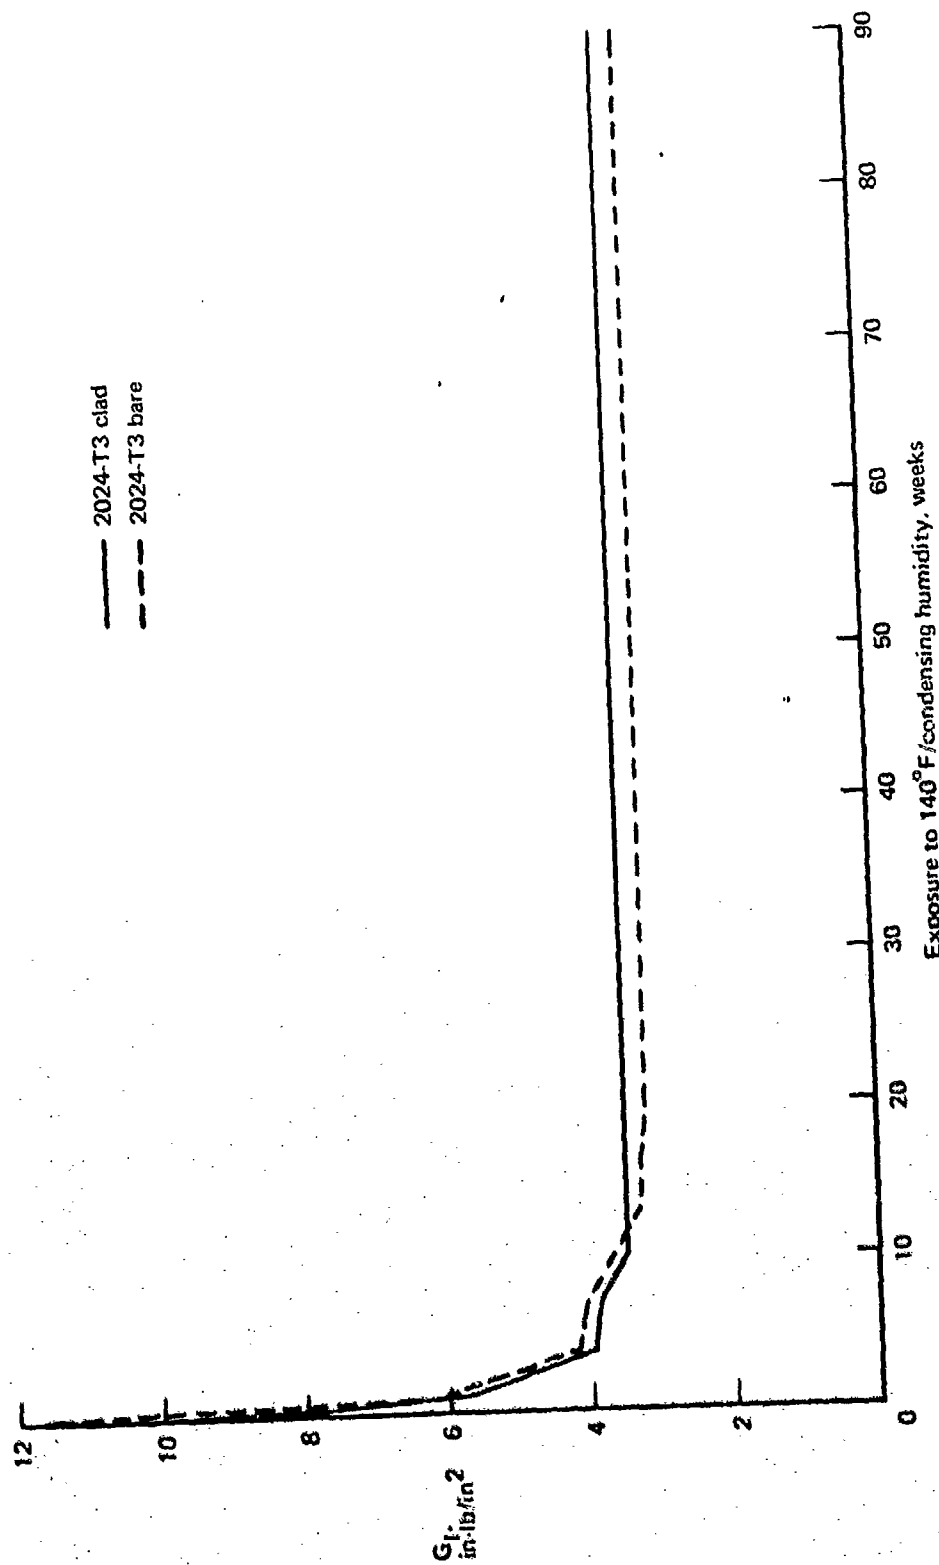
(a) Exposure Results: FM 123-2/BR 127, 2024-T3 Bare and Clad, Phosphoric Acid Anodize

Figure 15.—Influence of Long-Term Exposure on DCB Specimen

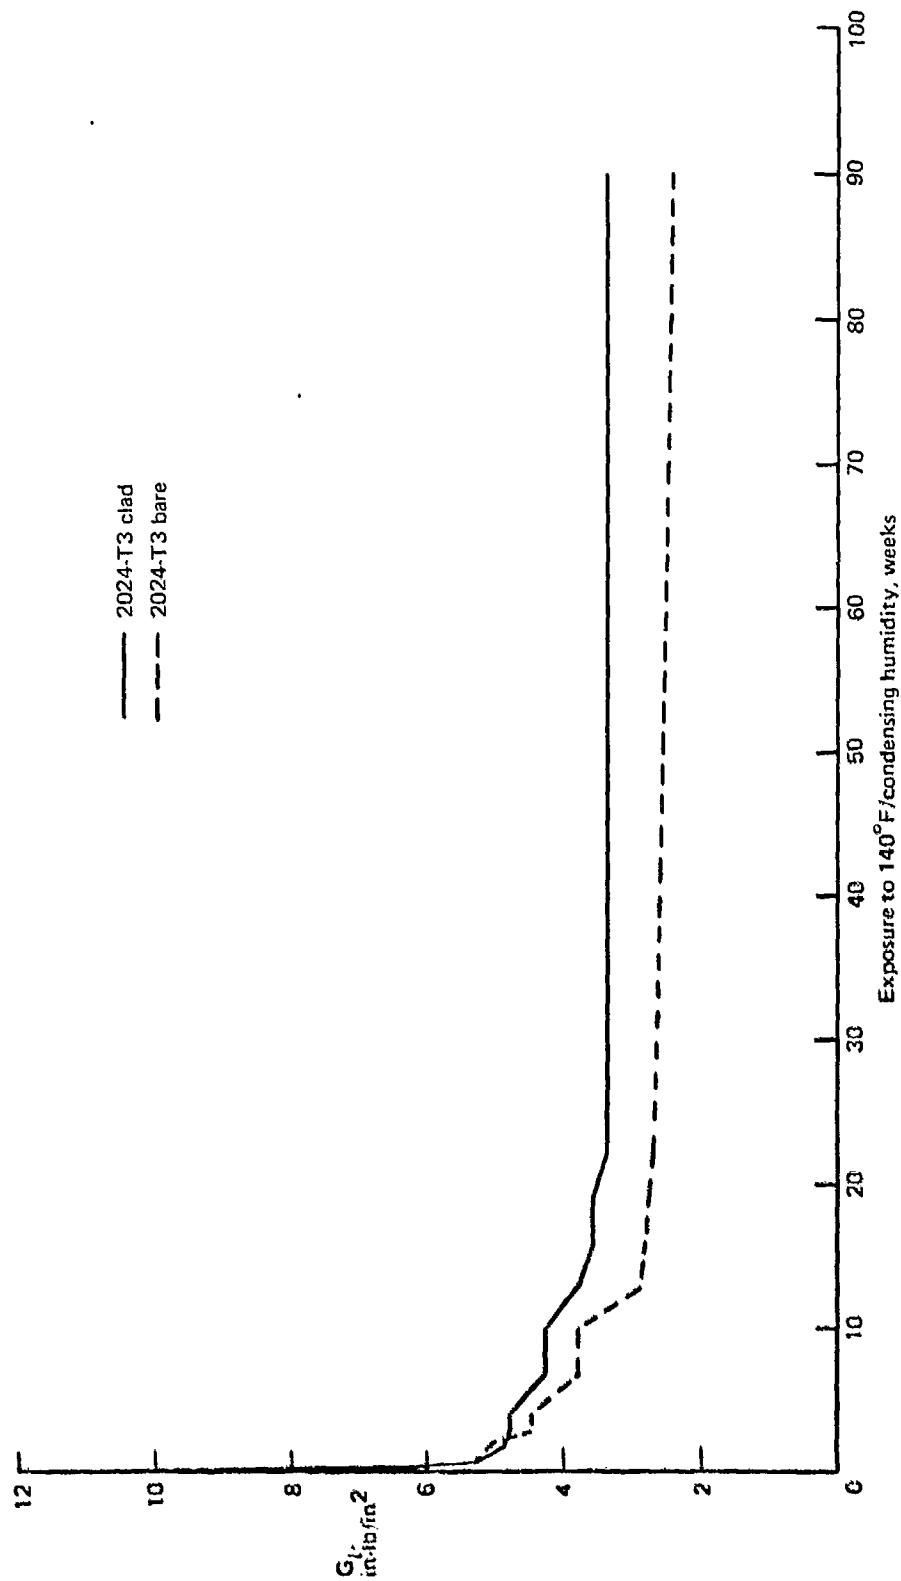
(b) Exposure Results: EA 9628/BR 127, 2024-T3 Bare and Clad, Phosphoric Acid Anodize

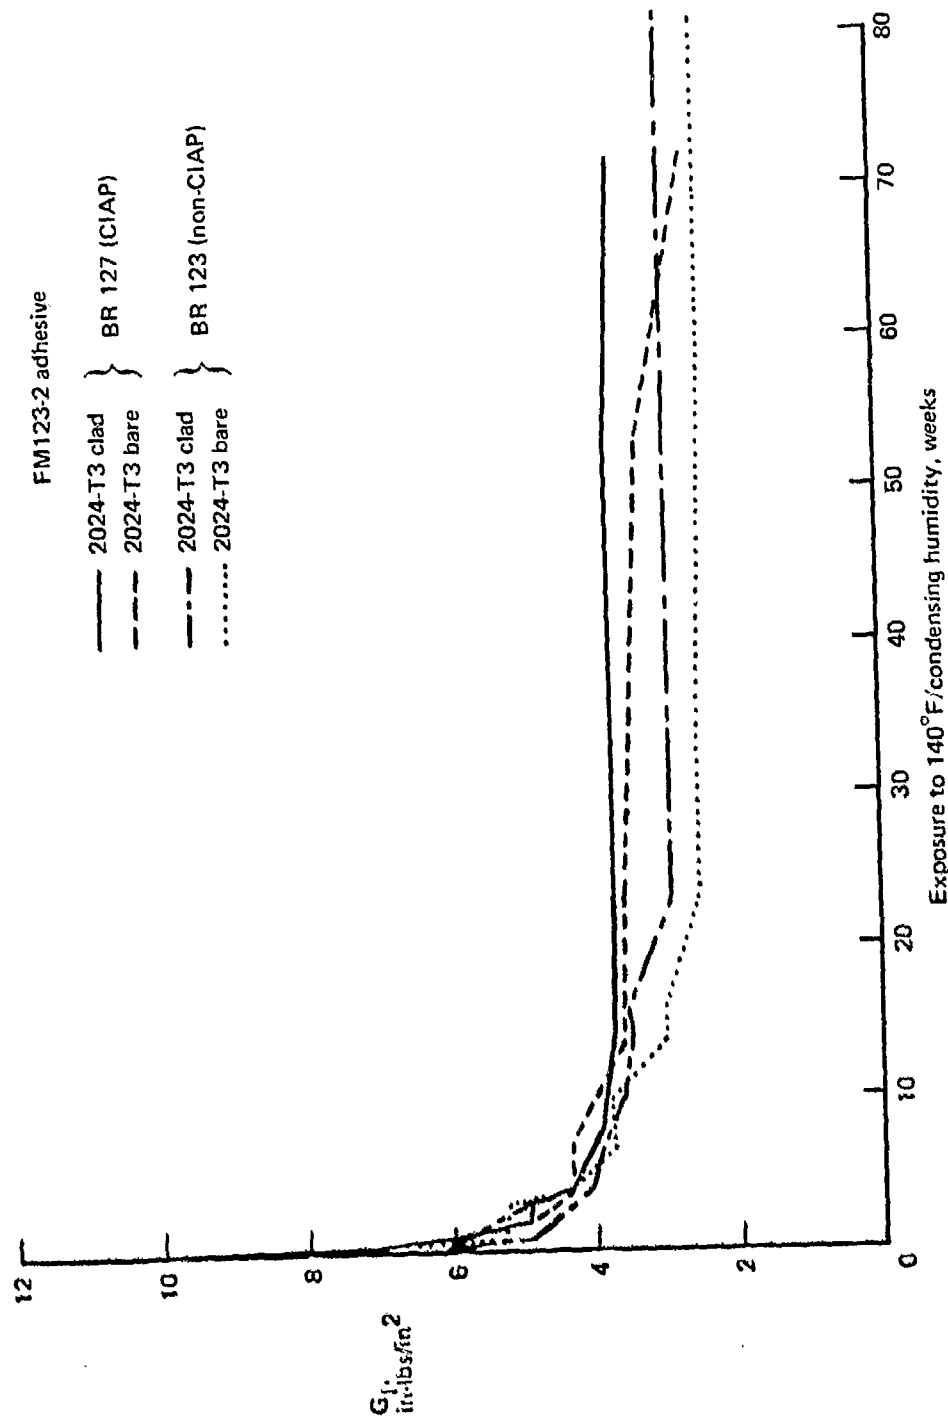
(a) Exposure Results, Phosphoric Acid Anodize Surface Preparation on 2024-T3 Bare and Clad with BR127(CIAP) and BR123(Non-CIAP) Primers

Figure 16.—Influence of Adhesive primers on DCB Specimen

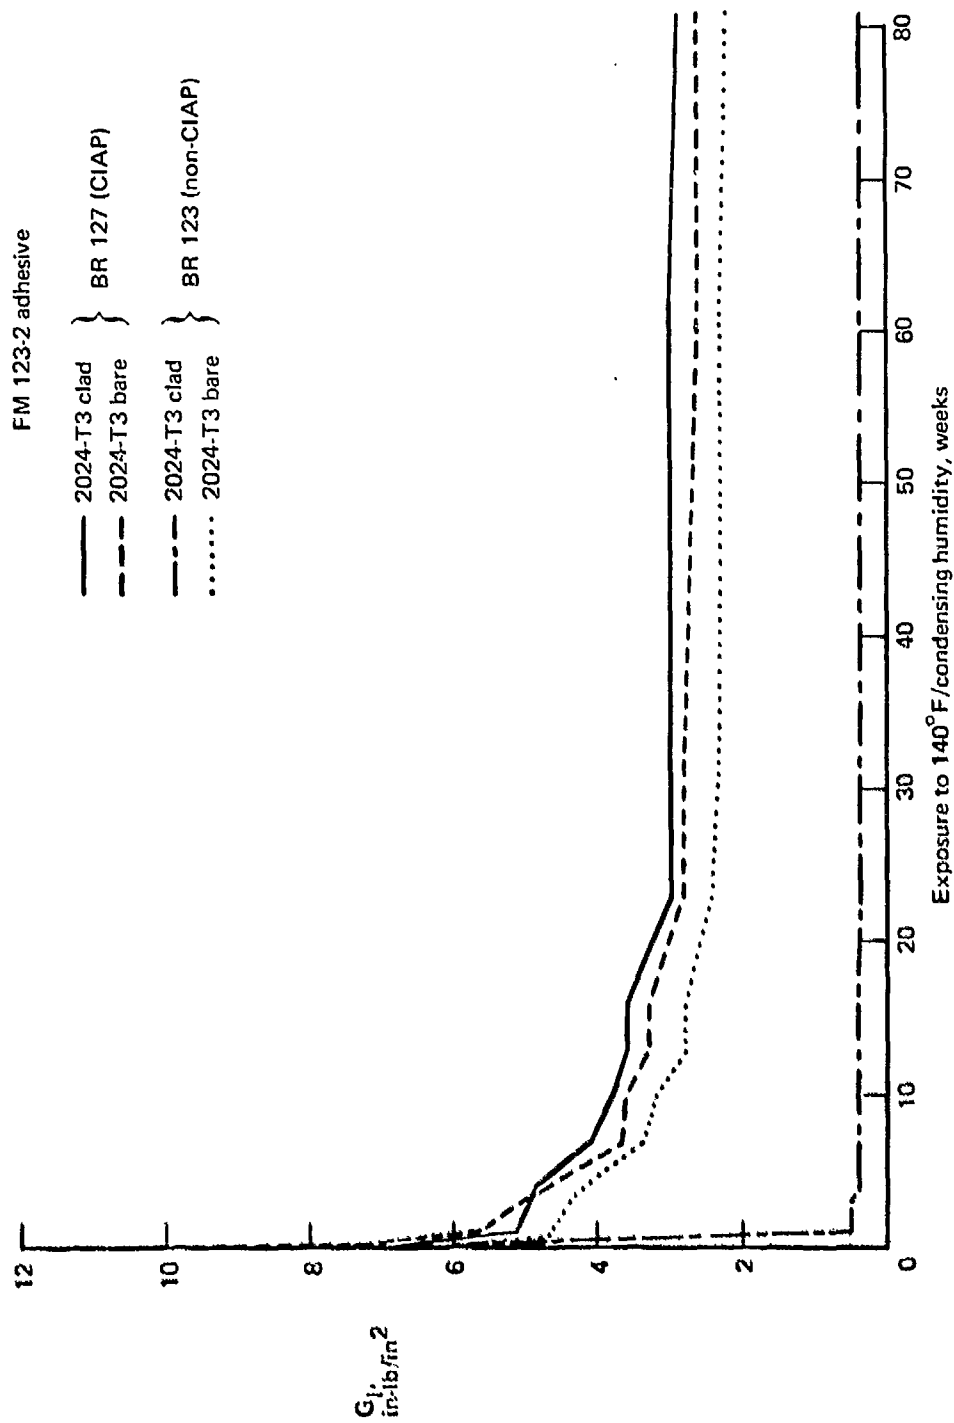
(b) Exposure Results—Chromic Acid Anodize Surface Preparation on 2024-T3 Bare and Clad with BR 127 (CIAP) and BR 123 (Non-CIAP) Primers

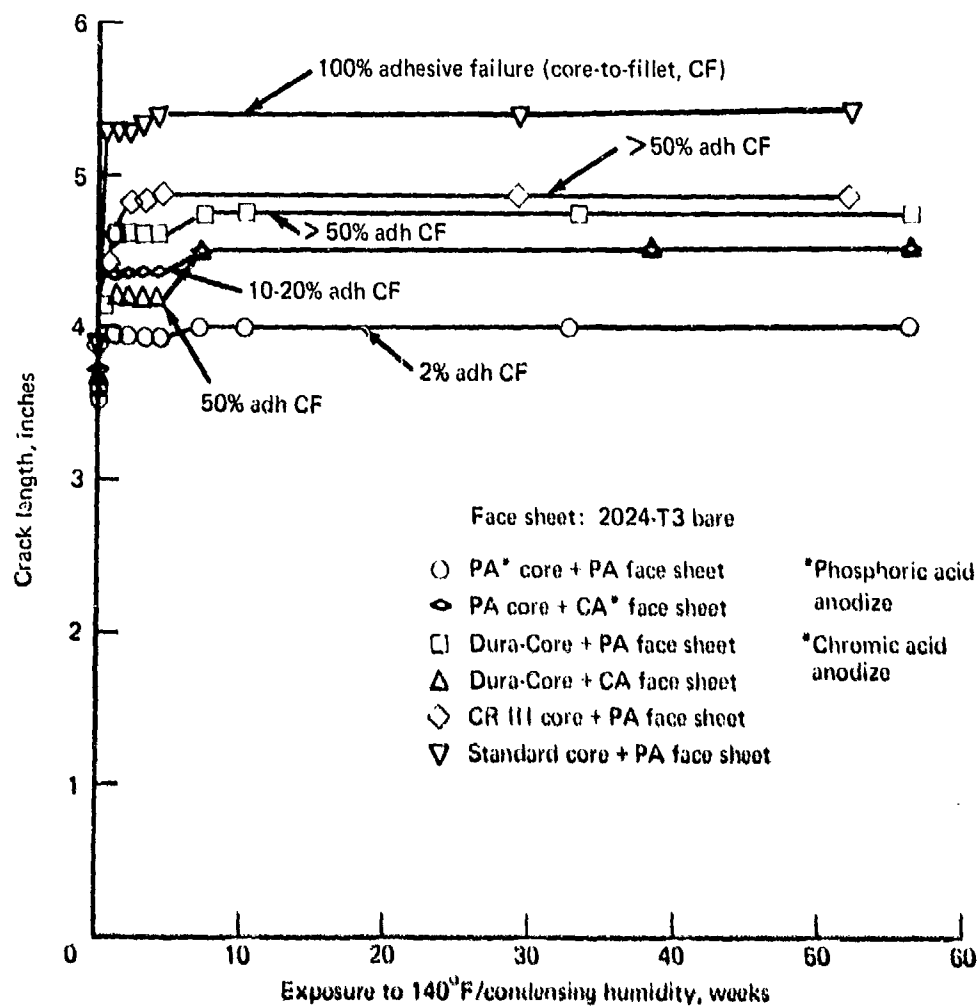
(a) SCB Specimens, EA 9628/BR 127

Figure 18.—Influence of Honeycomb Core and Face Sheet Surface Treatments on Environmental Durability

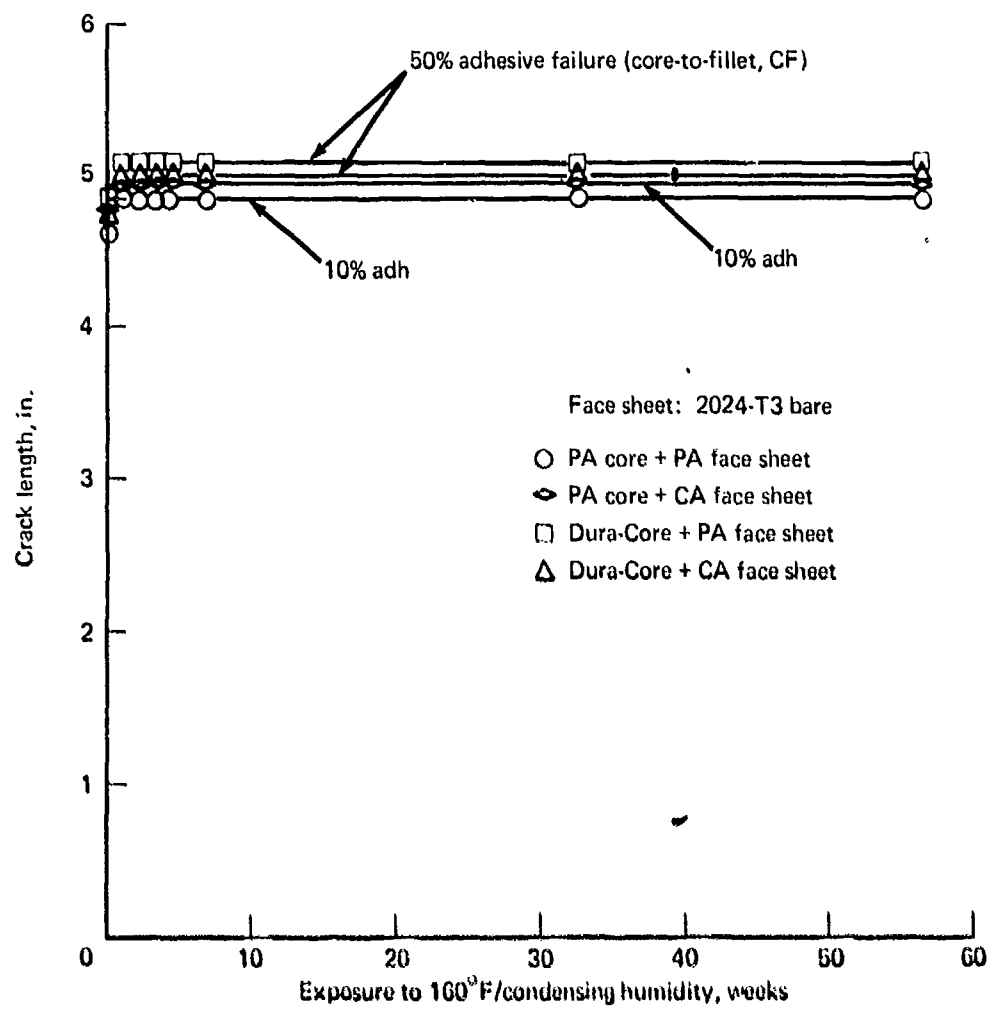
(c) SCB Specimens, AF 143/EC 3917

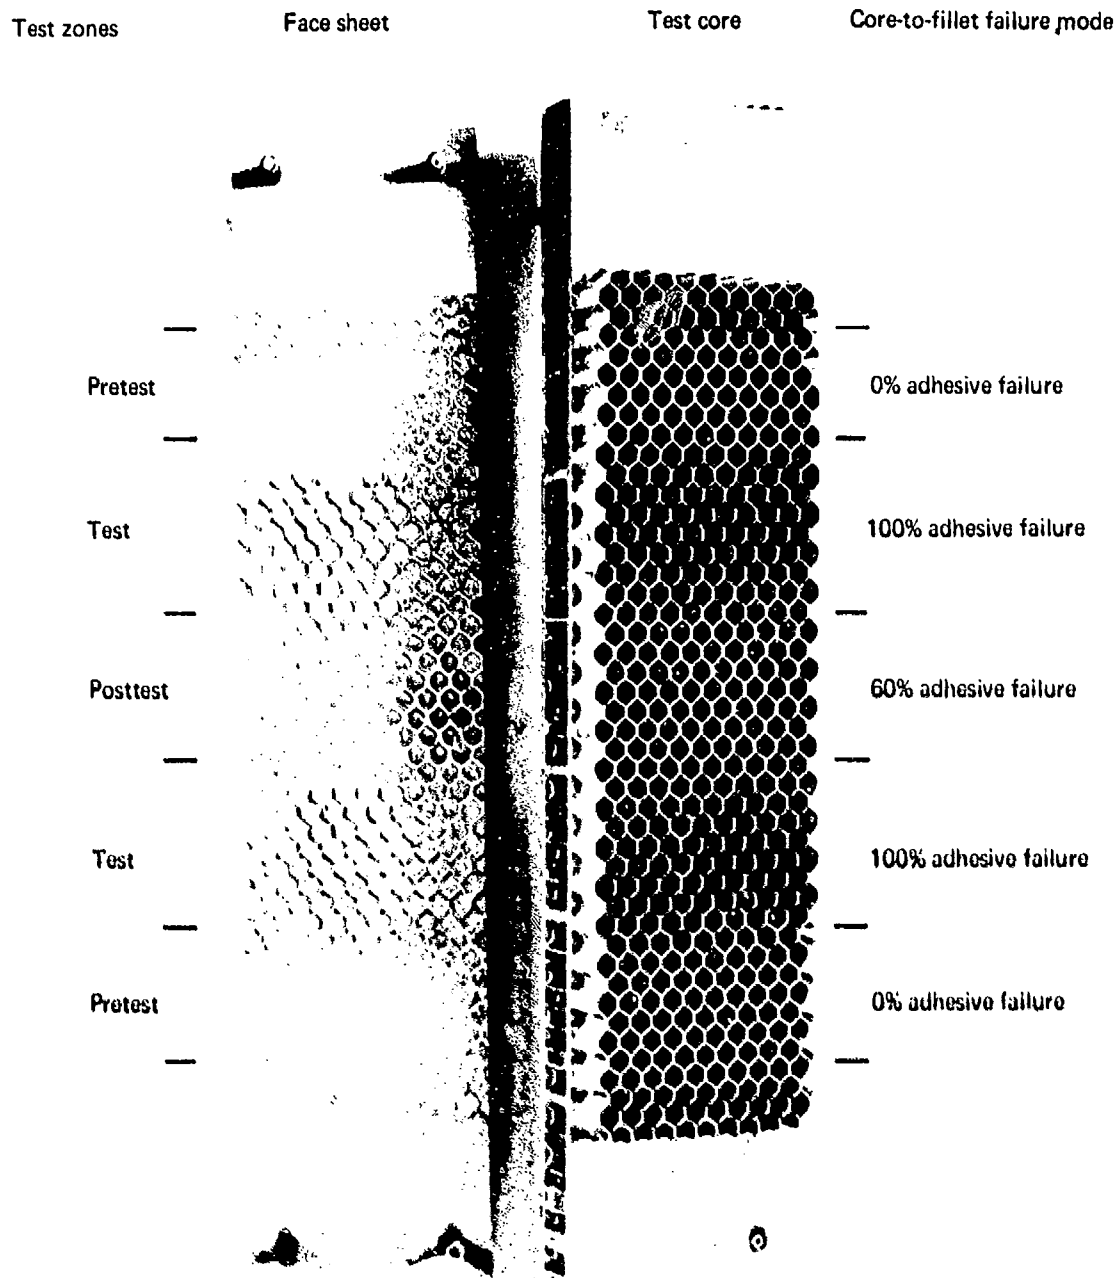
Figure 19.—Failure Modes in the Pretest, Test, and Posttest Areas of SCB Specimens Bonded with EA 9628 and Exposed to 140° F/Condensing Humidity

(c) Standard Core, Phosphoric Acid Anodize Face Sheet

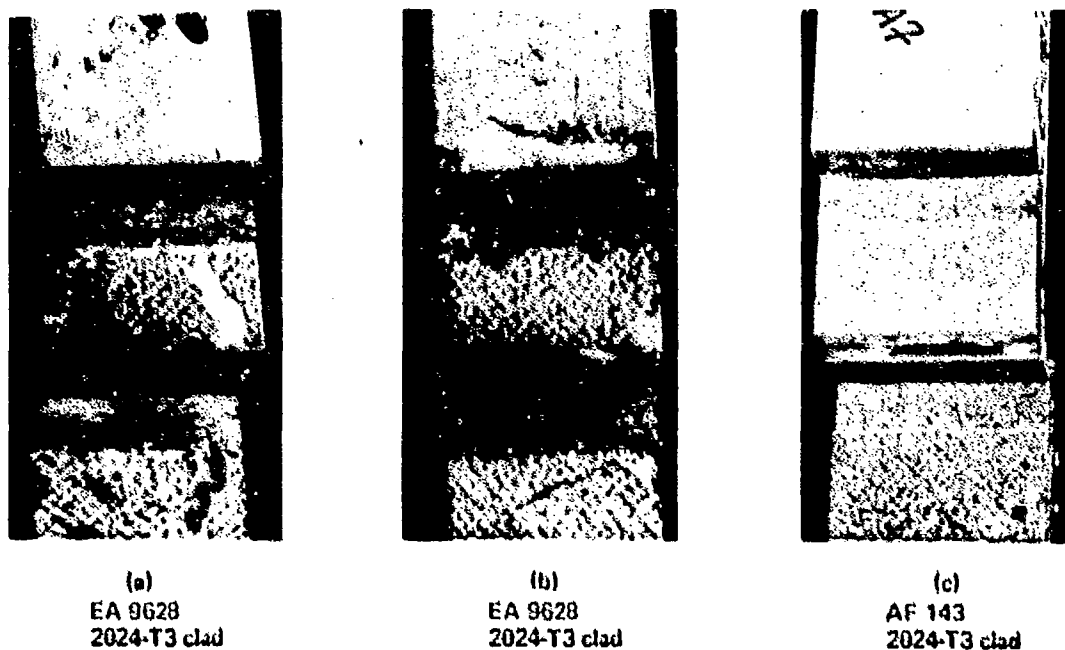
*Figure 22.—Typical Examples of Failure Modes for Slow Cycle Fatigue (0.8 and 10 cph)*

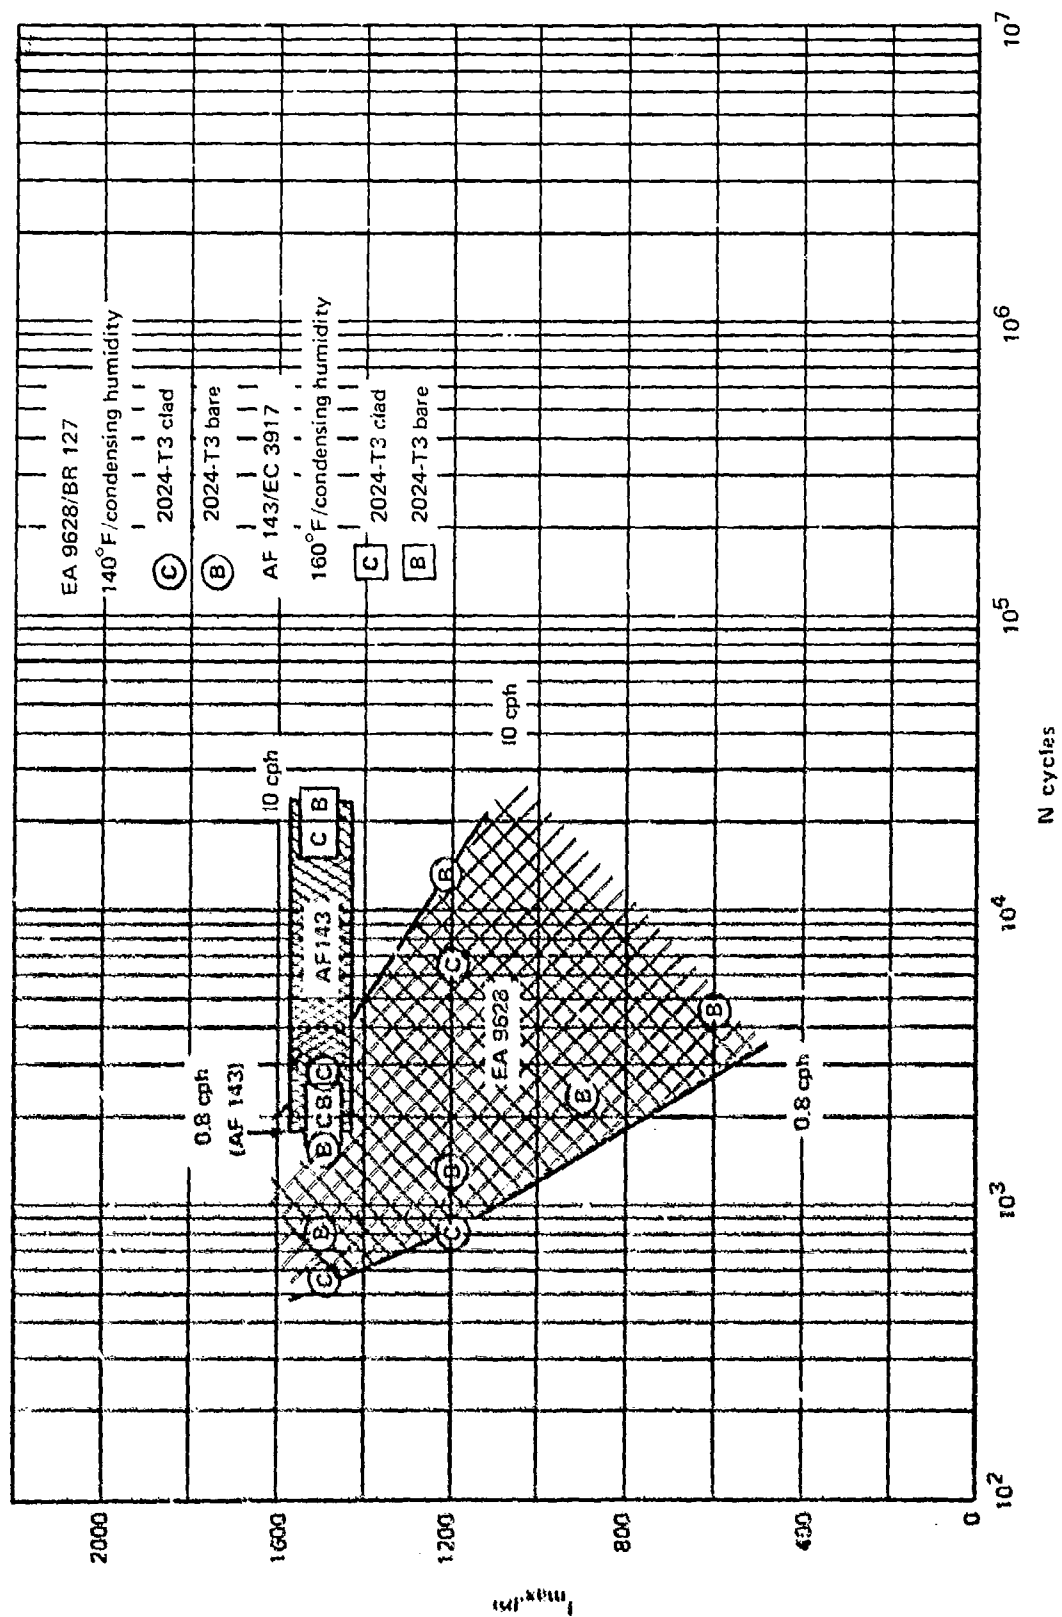
Figure 23.—Comparisons of Slow Cyclic Fatigue for 0.8 cph (Bell) and 10 cph for EA 9628/BR 127 and AF 143/EC 3917 Adhesive Systems
